23 CFR Part 667 Report

November 2020

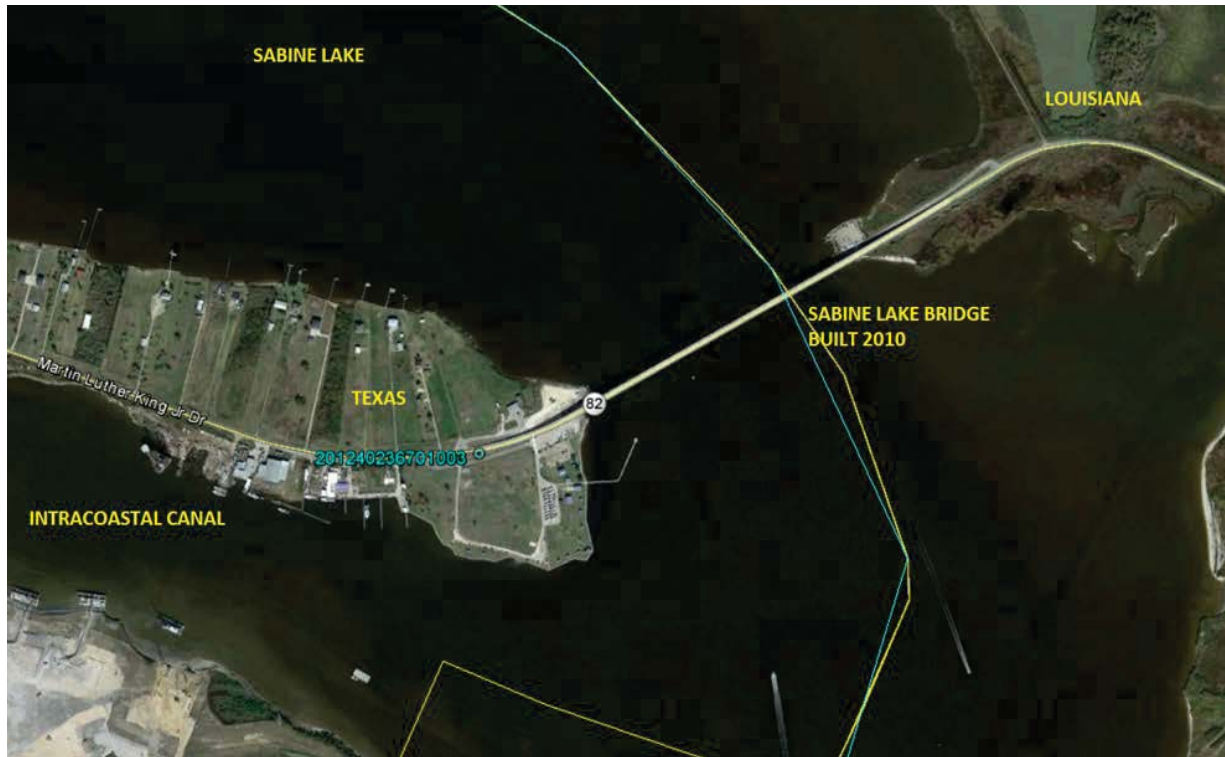
The SH82 bridge (over Sabine Lake, near the Louisiana border) was damaged by Hurricane Rita in 2005, requiring repairs to its fender system and other components. The same bridge suffered damages caused by Hurricane Ike in 2008. A more resilient bridge was built in 2010. The new bridge has not been damaged by subsequent storms including Hurricane Harvey. This recurrence is considered to have been adequately addressed by the new bridge.

Fig. 2 - Sabine Lake Bridge Built in 2010 and Nearby Intracoastal Canal

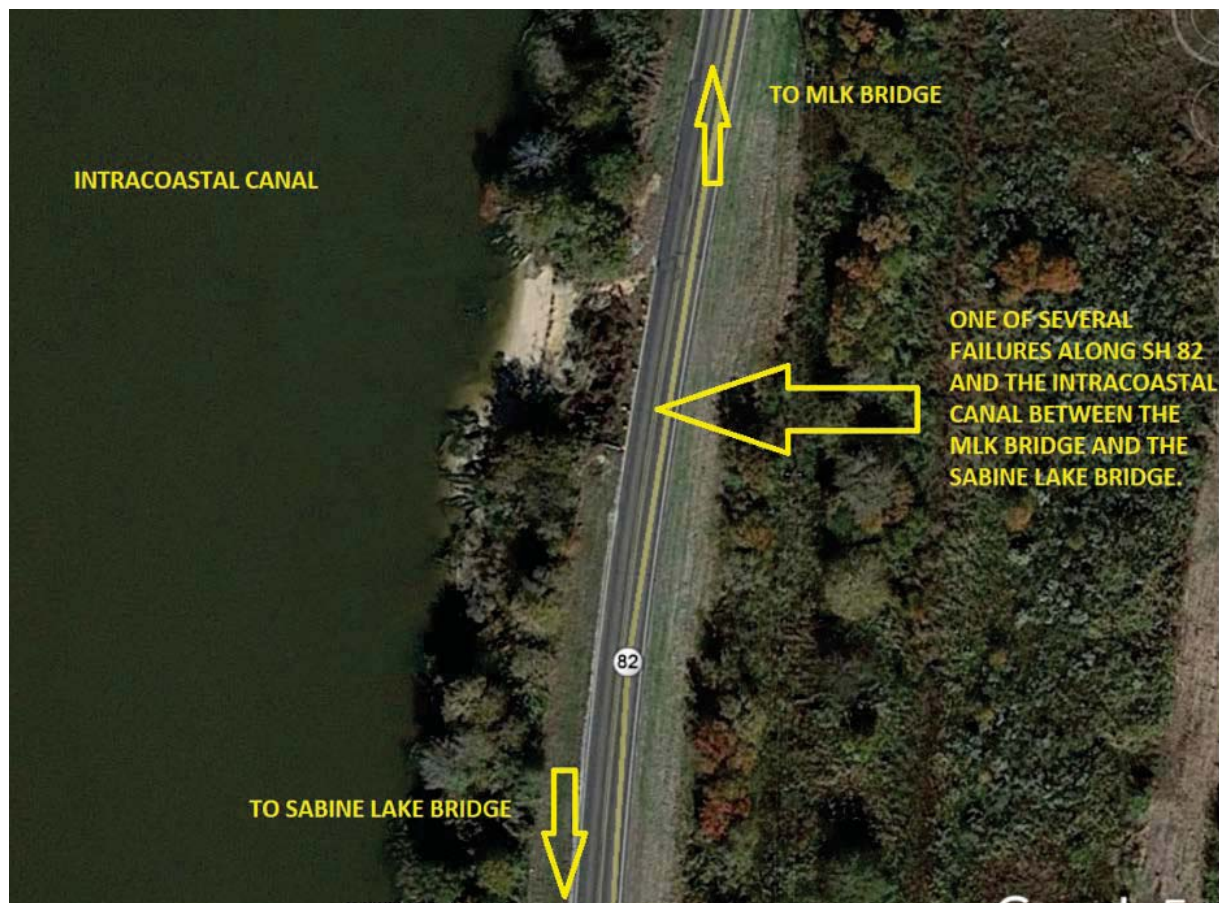
The nearby Intracoastal Canal bank has also faced problems. Several pavement failures have occurred on SH82 along the bank. Though this has not occurred more than once at the same location, it is noteworthy due to the similar mode of failure and likely solution. Erosion of the East bank is a continual issue due to ocean liner wake and the deepening of the canal through dredging. The bank is further eroded by tropical storms. Hurricane Harvey caused enough immediate erosion for the pavement edge to fail, as shown in Figure 3.

Fig. 3 – Pavement Failure due to Hurricane Harvey

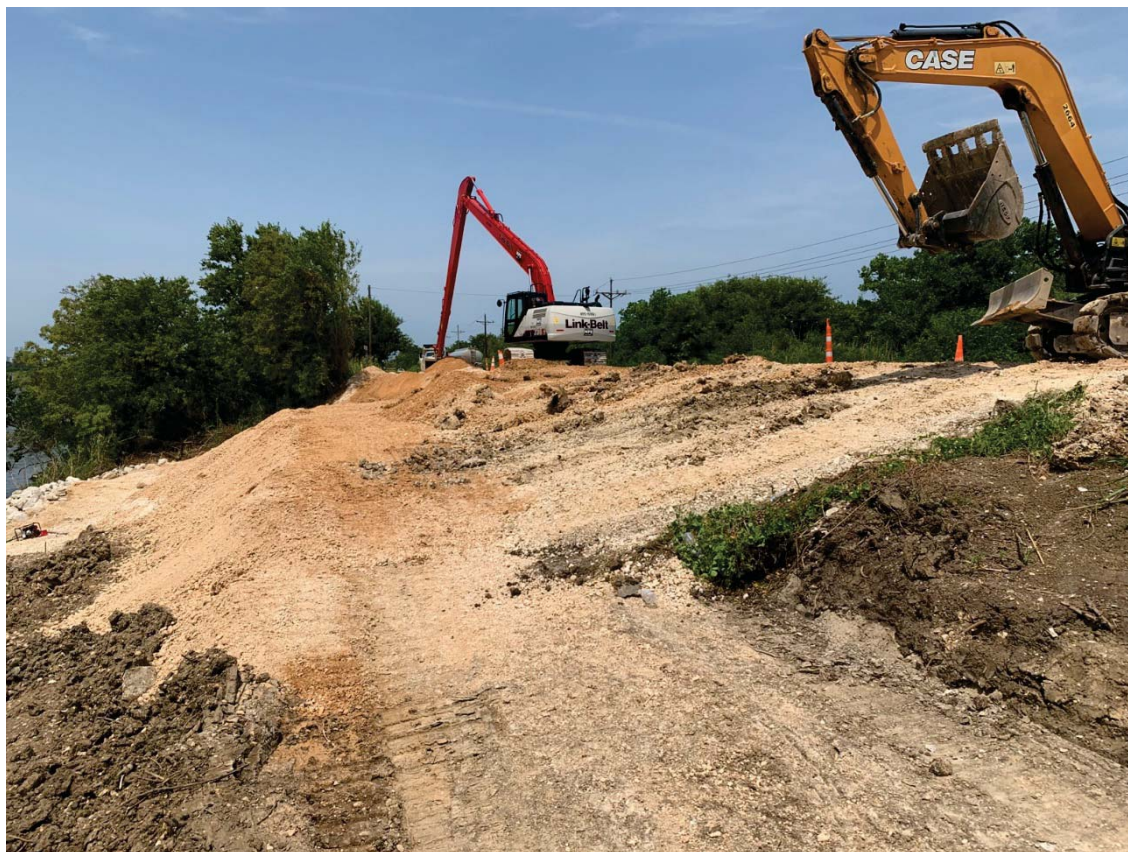
Fig. 4 - State Highway 82 Repairs

The Port Arthur Maintenance Office of TxDOT's Beaumont District quickly repaired the bank and pavement to quickly reopen all lanes of SH82.

Beaumont District personnel wish to improve the SH82 Intracoastal Canal bank by applying a captured-riprap system similar to the one successfully utilized on State Highway 87. SH87 follows the opposite canal bank, parallel to SH82.

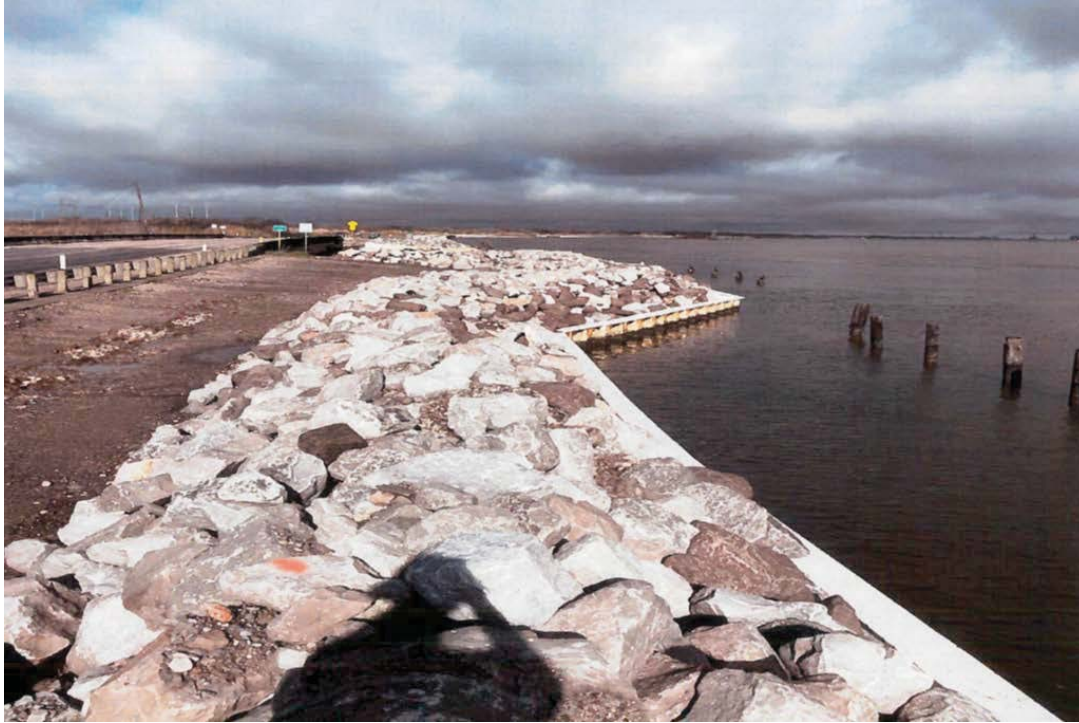
Fig. – State Highway 87 Successful Canal Bank Stabilization

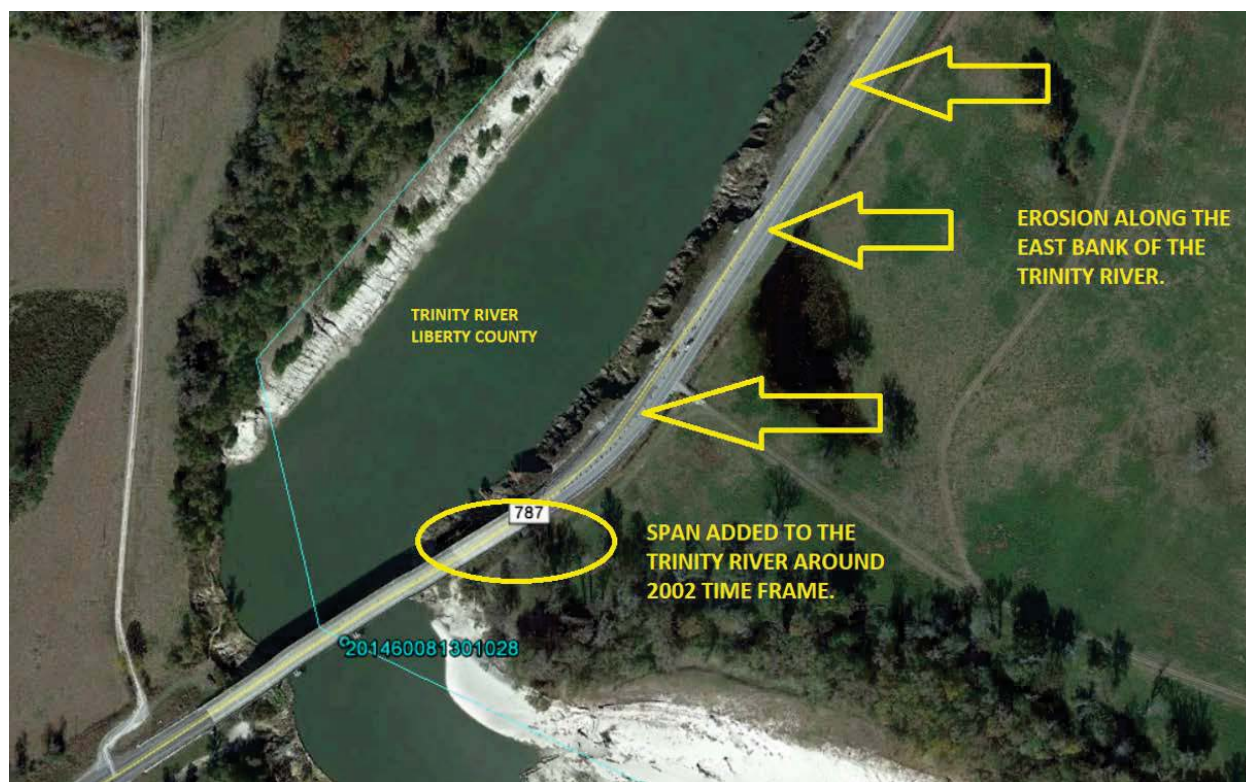
FM787 near the Trinity River required repairs to the bridge and adjacent pavement in 2001 after Tropical Storm Allison. In 2002, the bridge was extended such that its northeast abutment is now roughly 150 feet further inland from the embankment. While the bridge has been sufficiently resilient to withstand storms (including Hurricane Harvey), the nearby section of pavement has required ongoing repairs.

Fig. 2 – Farm-to-Market Road 787 at the Trinity River

While the roadway remains functional with one lane open, a \$15.55M project has been initiated for the stabilization of the East bank of the Trinity River through extensive application of sheet piling and riprap. With the foundation stabilized, the pavement will be reconstructed and the facility will be reopened in its original two-lane configuration.

A river migration study has been completed. TxDOT's Beaumont District plans to relocate the bridge and roadway as funds become available. This will address the periodic flooding and gradual encroachment of the river.

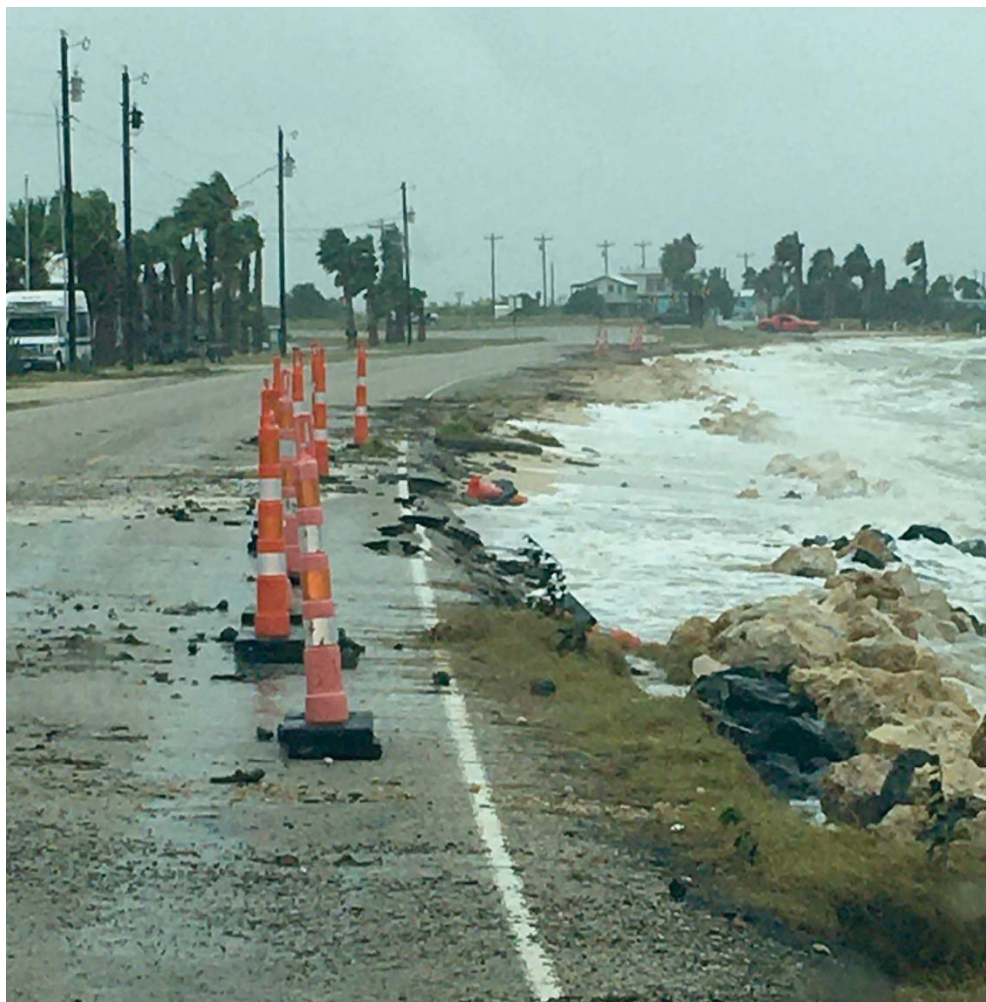
SH316 turns at Matagorda Bay to become a beachfront road. This section is vulnerable and faces recurring damage. The problem is compounded by the gradually receding coastline. TxDOT's Yoakum District keeps the edge repaired and has placed riprap for now. The District is also coordinating with local authorities for a more permanent mitigation project.

Fig. 3 – State Highway 316 Storm Damage

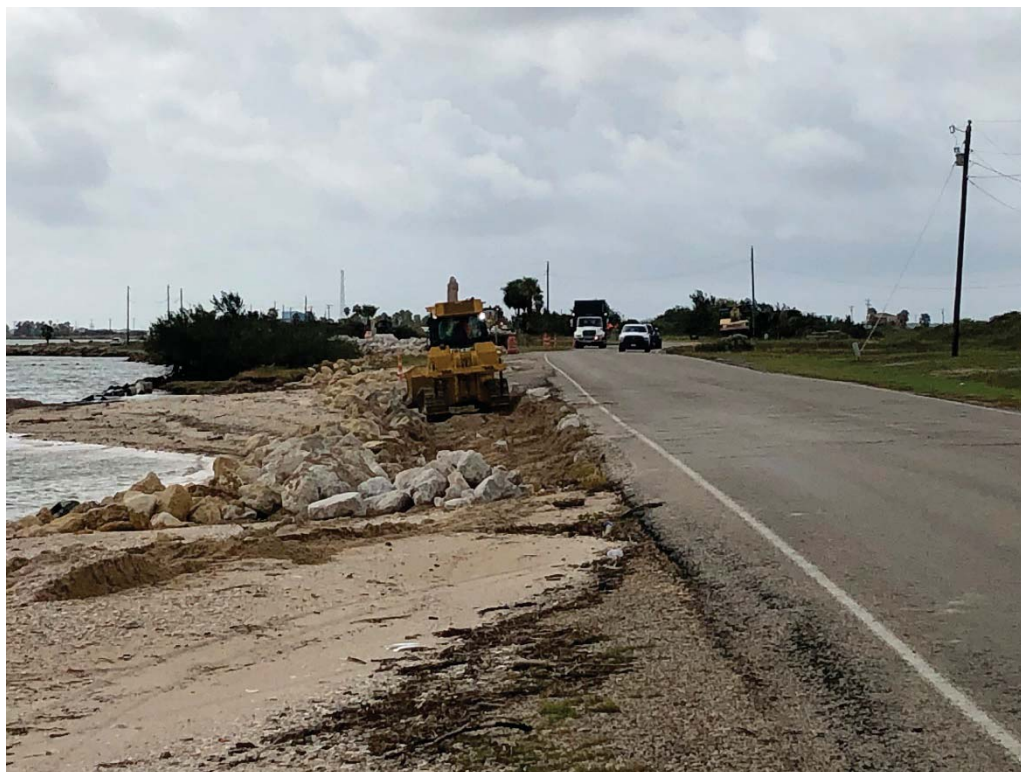
Fig. 4 – State Highway 316 Riprap Placement
